**Loading, Degradation and Repair of
F-111 Bonded Honeycomb Sandwich
Panels - Preliminary Study**

S. Whitehead, M. McDonald and
R.A. Bartholomeusz

DSTO-TR-1041

**Airframes and Engines Division
Aeronautical and Maritime Research Laboratory**

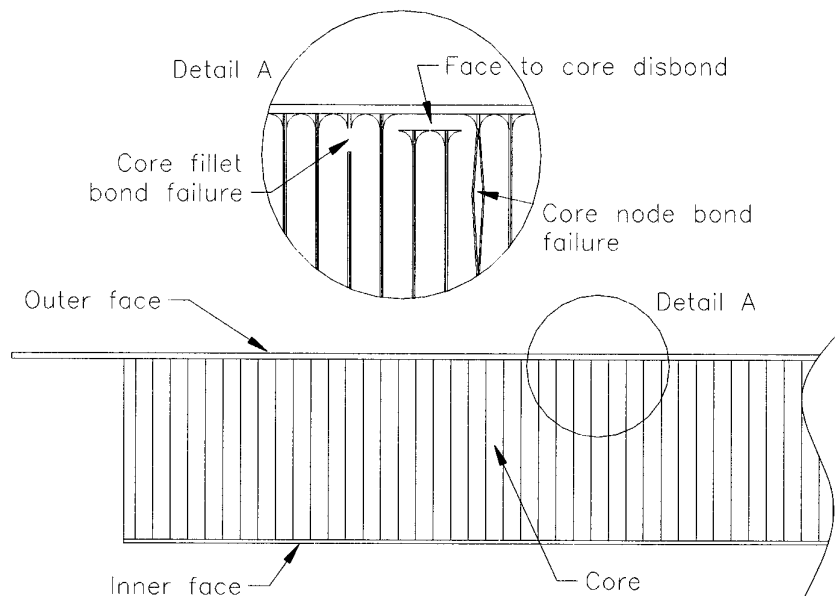
Adhesive bond failure is generally exhibited in three types of failure; face to core disbonding, core fillet bond failure and core node bond failure. These are described in Figure 2 (adapted from Reference 9). Degradation of the bond strength through exposure to moisture and free water will decrease the strength of these bonds. Sandwich panels are generally designed so that the core fails in shear before the face-to-core bond or fillet bond fails. Reduction in bond strength may change the failure mode and cause premature failure of the panel.

Figure 2: Failure of adhesive bonds in sandwich panels after degradation.

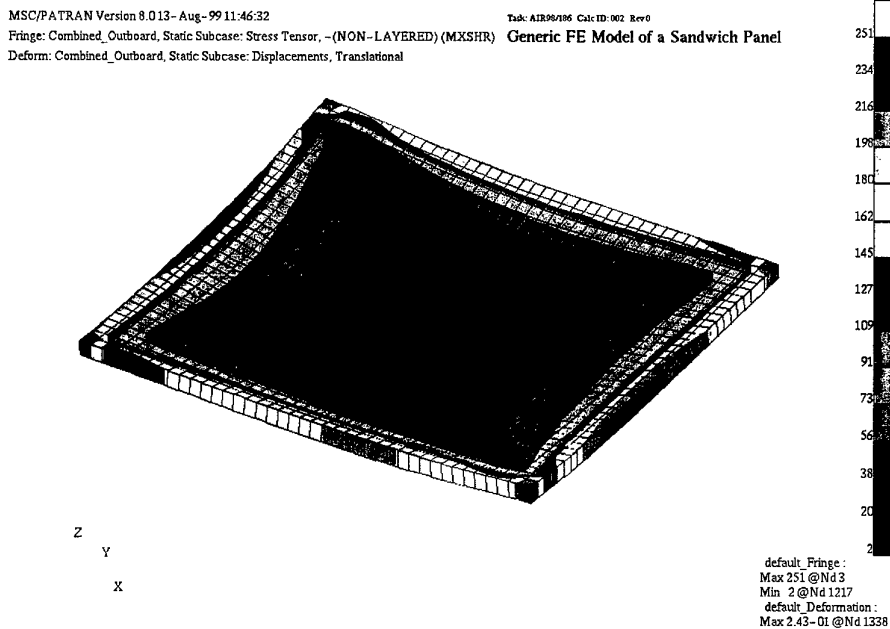
Figure 12 shows a contour plot of the shear stresses in the core. The core shear stresses are representative of the shear loads experienced by the face to core bond. The stresses compare very well with the OEM calculations, despite the coarseness of the simplified FE model. (It is important to note that both the OEM calculation, and the FE analysis reported here, were both similarly simplistic and the true shear stress distribution in panel 3208 may be different.) The results also indicate higher core shear stresses near the panel edges (~250 psi).

Figure 12: Contour plot of shear stresses in the core

Based on the findings of the simplified FE model, the application of the ultimate static load to the panel is sufficient to generate core shear stresses of around 250 psi. At this time no conclusions can be drawn regarding the ability of the panels to withstand the ultimate load in the degraded or damaged condition due to the lack of a knock down factor or allowable for panel degradation in sandwich-panels. Work is required to develop these knockdown factors.

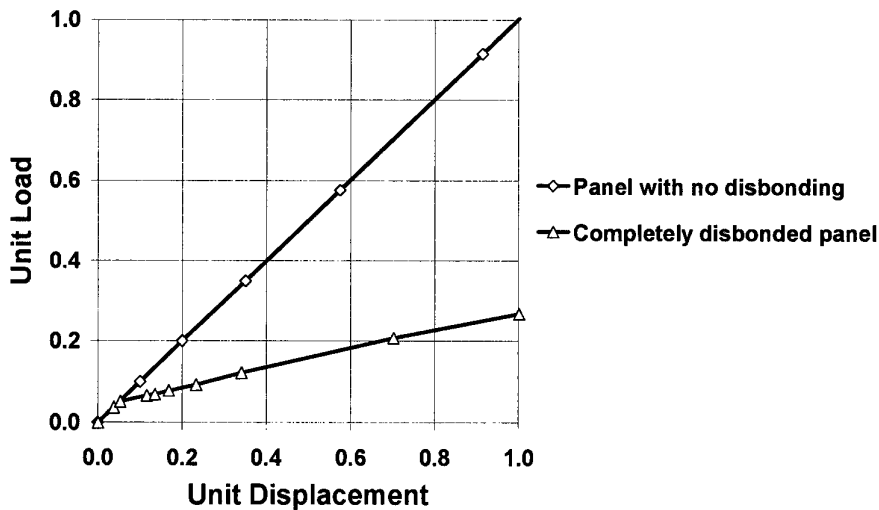
The load-displacement response is shown in Figure 14 and this shows that the onset of general buckling instability begins at about 5% of ultimate load. Further, more realistic, work is planned which will consider the effect of smaller disbonded regions.

Figure 14: Load-displacement response of an intact panel and a completely disbonded panel.

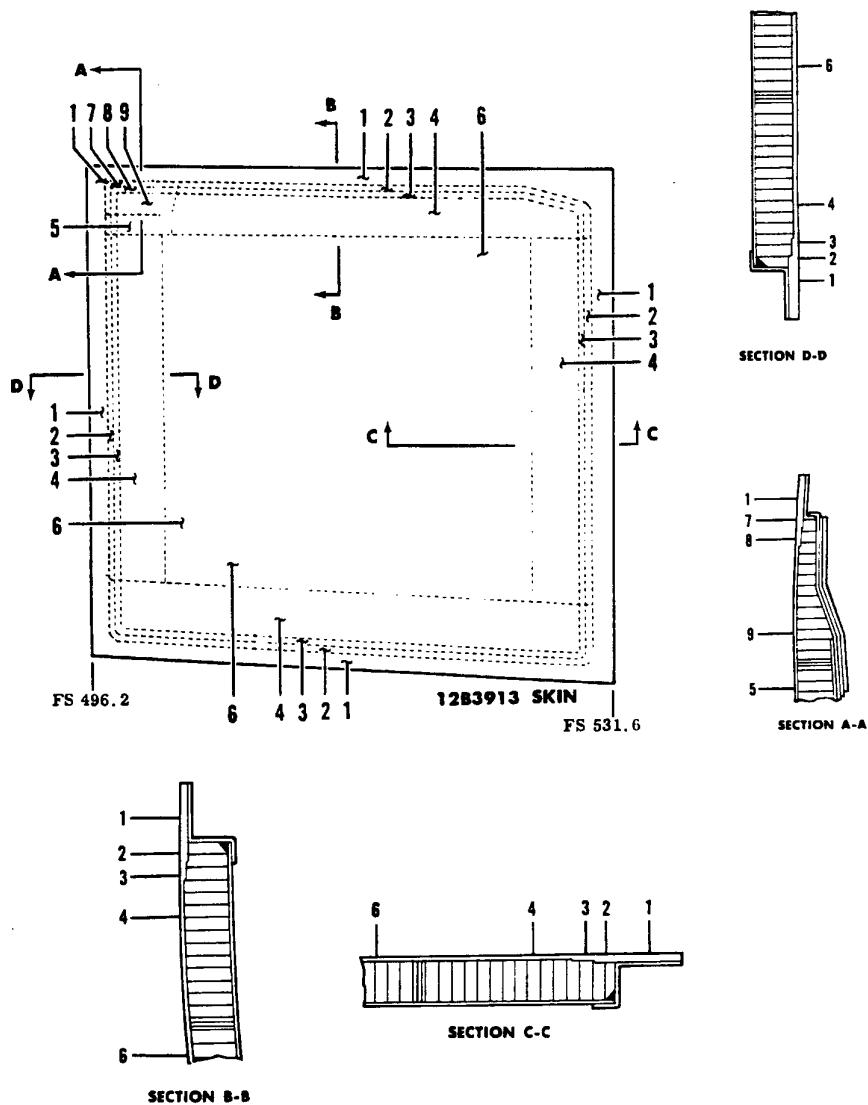
Figure 16: Structural detail of panel 3208. [2]

Table 2 is a description of the defects that have occurred in panel 3208 along with pictorial representations of the defects. (Note that these diagrams are not intended to be an exact replication of the defect, rather an approximate representation of their size and shape.)

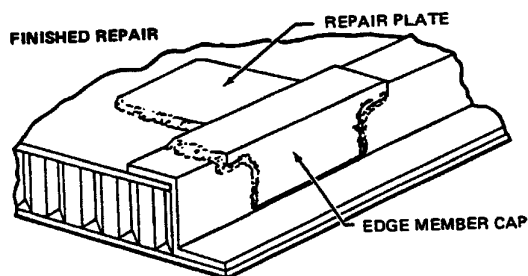
Figure 20. Finished repair for a hole or void in the face adjacent to an edge member.

This repair is for damage in the face or core adjacent to an edge member. The panel is cleaned and a moisture removal procedure carried out to dry the honeycomb core. The damaged area and edge member flange are routed to remove the damage. A core plug is manufactured and both the core plug and routed hole are prepared for bonding by performing a standard surface preparation for adhesive bonding. The plug and repair plate is then bonded to the damaged panel. An edge member angle cap is installed to cover the repair plate and edge member and finally, a honeycomb leak test carried out. A diagram of a finished repair is shown in Figure 20.

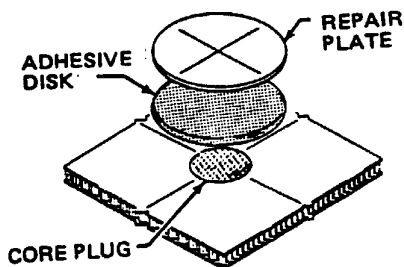
Figure 21. Hole repair using an overlap patch.

This repair is similar to D12 but without the complication of being adjacent to an edge member. The panel is cleaned, the damage removed and the panel is dried. The repair plates and core plug are then fabricated to suit. The surfaces to be bonded are prepared and the core plug installed, followed by the installation of the repair plate (note that the repair plate is non-flush) by bonding. Finally, the repair is surface finished and a honeycomb leak test performed.
